STRUCTURAL INTEGRITY & ASSESSMENT AUDIT REPORT

KUNJ VIHAR CGHS LTD.

PLOT NO 19, SECTOR 12, DWARKA, NEW DELHI - 110078.

UNIQUE DESIGNERS & ENGINEERS PVT. LTD.

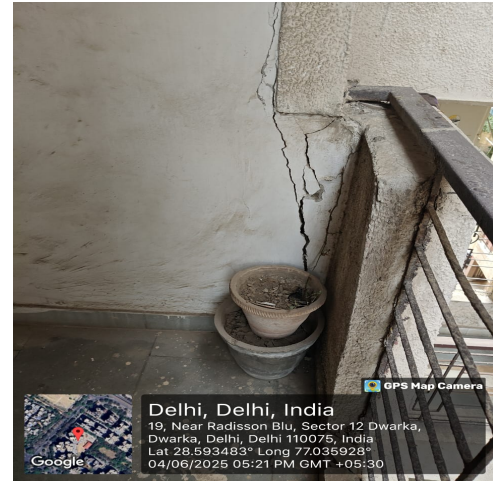
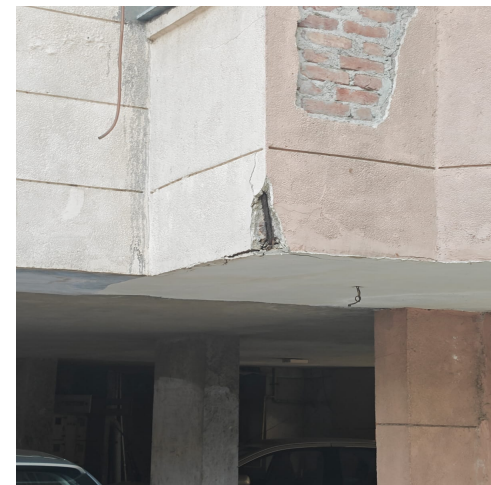
1. Cracks in Balcony Beams – 1st and 3rd Floor

- Linear cracks were observed in the balcony beams on the 1st and 3rd floors. Cracks appear near the cantilever ends, mostly on the soffit (bottom surface), suggesting flexural stress-induced failure.

- These cracks have developed due to prolonged cantilever loading, thermal expansion/contraction, and exposure to weathering.

- Continuous widening of cracks can lead to water seepage, corrosion of embedded reinforcement, spalling of concrete, and eventual reduction in load-bearing capacity of the cantilever elements.

- Inject epoxy grout into cracks.
- For significant distress, use carbon fiber reinforced polymer (CFRP) wrapping.
- Apply waterproofing and slope correction to drain water away from beam surfaces.
- This location contains all three types of cracks—minor, moderate, and major. Kindly refer to the repair methodology and recommended treatments as detailed on Pages 87 to 92 & 114 to 120 of this report. Apply appropriate solutions based on the crack severity observed at each location.

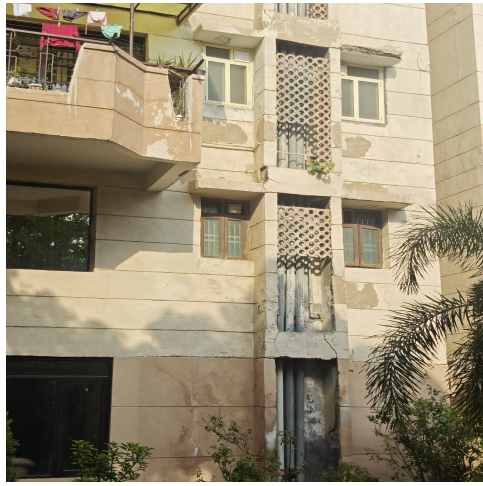
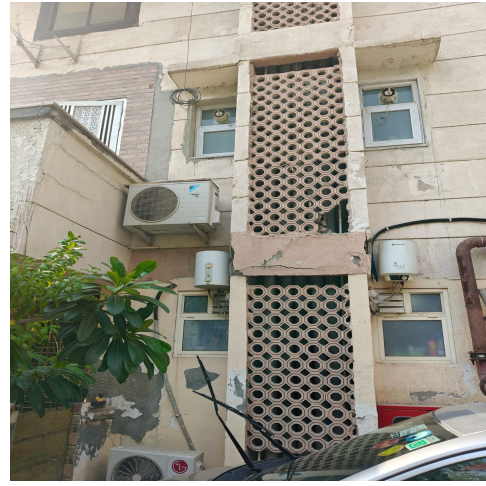
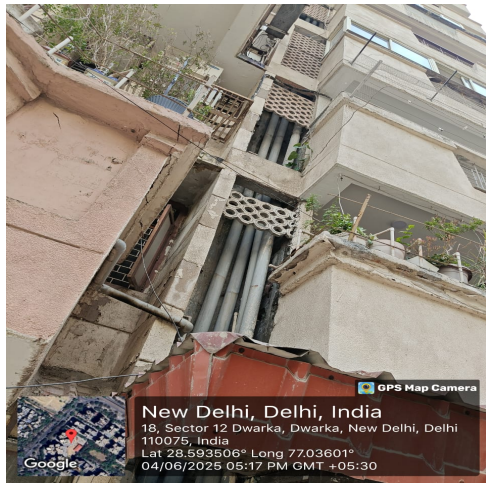
- Visible damp patches and calcification marks were present in all floor-level shaft walls. Water dripping was observed in some cases, particularly near plumbing interfaces.

- Seepage is due to aging or failed waterproofing, poor sealing of plumbing joints, or degradation of shaft wall surfaces over time.

- Continuous seepage can weaken the concrete, corrode reinforcement, damage utilities, and increase the risk of fungal growth and foul odors inside the shafts.

- Apply (PU) injection grouting to seal active leaks.
- Replace old pipe gaskets and refit joints with water-tight sealants.
- Use internal waterproof coatings and external membranes for protection.
- Recommended treatments as detailed on Pages 87 to 92 & 114 to 120 of this report.

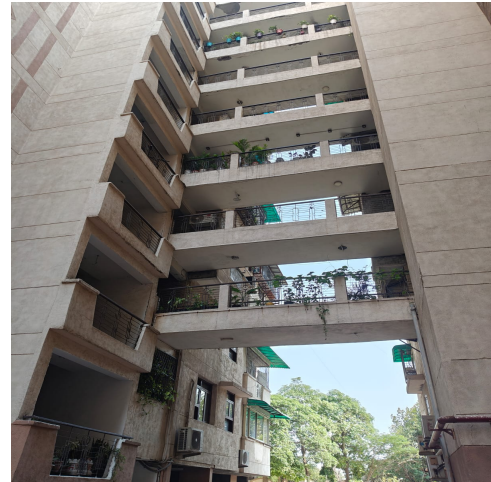
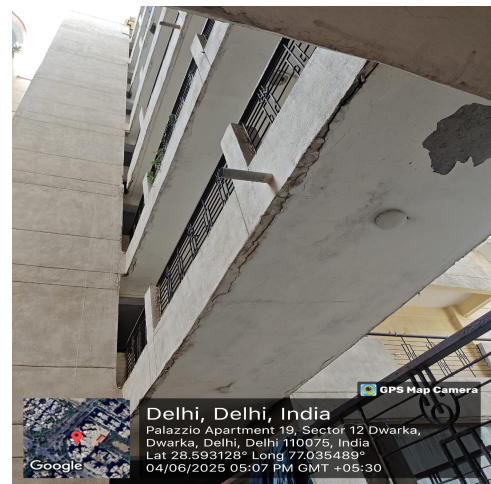
3. Beam Cracks – Ground Floor Passage Between Type A1 and Type A2

- Diagonal and flexural cracks were observed in RCC beams in the passage connecting sections type A1 and type A2. Cracks were most visible near beam-column junctions and mid-spans.

- Cracks are due to accumulated structural loading over time and differential deflection between wings.

- Potential weakening of load paths in a key circulation area. Prolonged inaction can result in deflection, instability, or even progressive cracking along connected members.

- Strengthen using steel jacketing Or RC jacketing or polymer mortar repair/micro concrete.
- Refer repair methodology and recommended treatments as detailed on Pages 987 to 92 & 114 to 120.

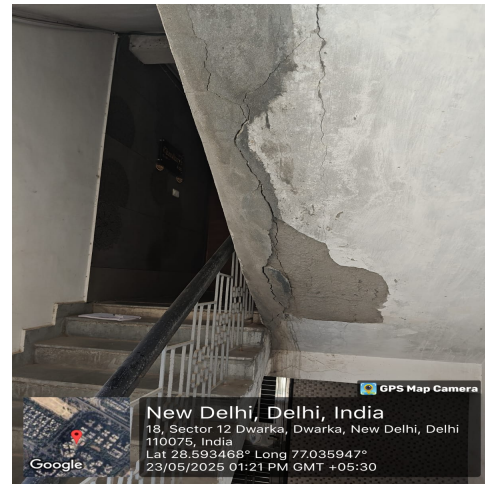
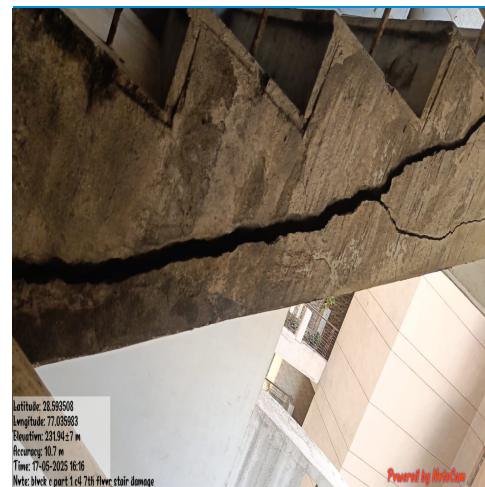
4. Beam Cracks Around Stair Wall – All Floors

- Horizontal and vertical cracks were noticed in beams supporting stair walls on each floor. These cracks were mostly continuous at the same level on every floor, showing consistent stress impact.

- Cracks likely developed due to vibration from regular use, long-term shrinkage, and rigid wall-beam connections lacking movement tolerance.

- Cracks may propagate into adjacent walls and lead to loss of load-sharing capacity between stairs and core beams, posing evacuation and safety concerns.

- Apply sealants in cracks.
- Retrofit stair beams with additional rebar or polymer mortar repair or micro concrete.
- Pages refer 87 to 92 & 114 to 120.

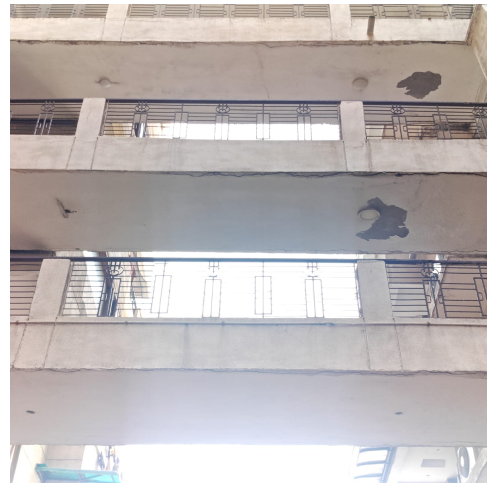
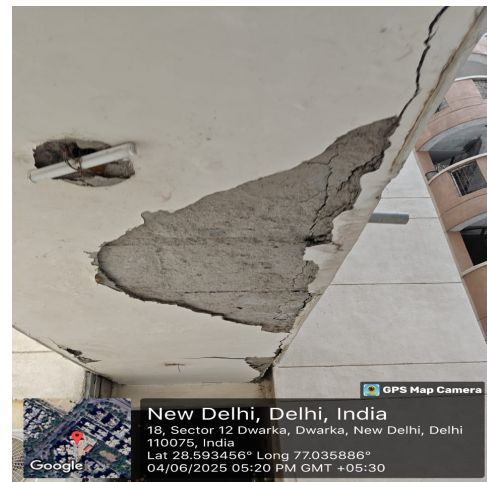
5. Beam Crack at Passage End – 1st Floor

- A significant crack was identified at the end of the passage beam at the 1st floor junction, where differential structural movement appears to have concentrated stress.

- This is a service-related crack due to edge restraint, unequal support stiffness, or improper load transfer over time.

- Stress concentration may induce torsional cracking or lead to eventual shear failure if left unattended.

- Add additional reinforcement if exposed (by weld method).
- Retrofit stair beams with additional rebar or polymer mortar repair or use micro concrete.
- Monitor with strain gauges for movement tracking.
- Refer to the repair methodology and recommended treatments as detailed on Pages 87 to 92 & 114 to 120 of this report.

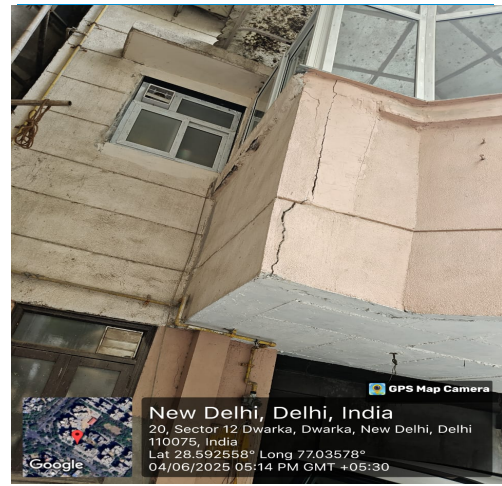
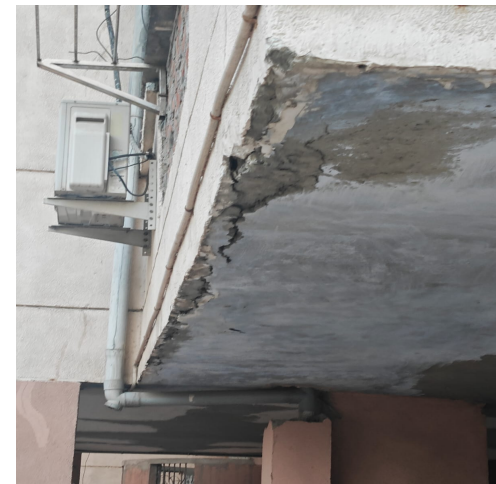
7. Balcony Crack – TYPE-C2 (1st Floor)

- A wide flexural crack was seen at the base of the balcony slab near the wall connection.

- Crack likely due to cantilever stress, temperature fluctuation, and insufficient drainage leading to water retention.

- This location contains all three types of cracks—minor, moderate, and major. Kindly refer to the repair methodology and recommended treatments as detailed on Pages 87 to 92 & 114 to 120 of this report. Apply appropriate solutions based on the crack severity observed at each location.

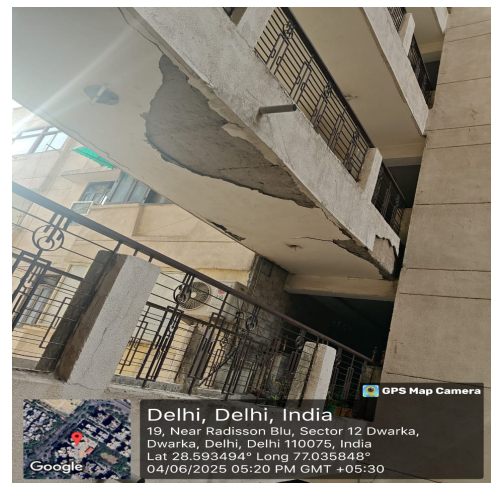
- Seepage marks and damp patches were observed on the floor slabs and sidewalls of the passage areas on multiple levels. Numerous potted plants are placed along the passage, and excessive watering was noted. Rust stains are also visible on some ceiling surfaces, indicating ongoing reinforcement corrosion.

- Continuous and excessive watering of potted plants has resulted in water accumulation and seepage through slab joints and cracks. Lack of waterproofing and proper drainage has allowed moisture to reach embedded reinforcement.

- Corrosion of reinforcement leading to expansion and cracking of concrete.
- Gradual weakening of the slab and reduced load-bearing capacity.
- Fungal/mold growth affecting aesthetics and hygiene.
- Degradation of plaster and paint layers.

- Relocate plants or place waterproof trays below pots.
- Perform anti-corrosive treatment and patch repair where rusting is evident.
- Apply waterproofing treatment to slab surfaces.
- Replaster and repaint with moisture-resistant materials.
- Regular monitoring for corrosion signs in affected zones.

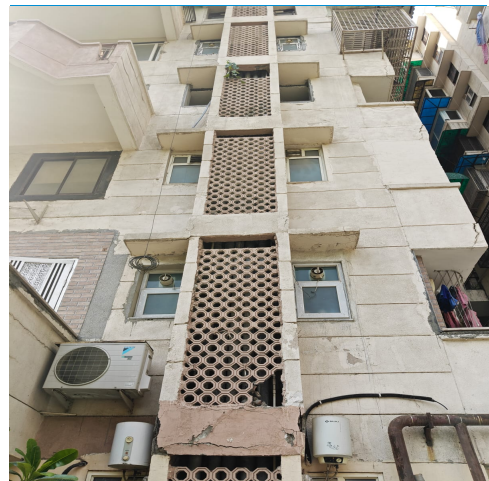
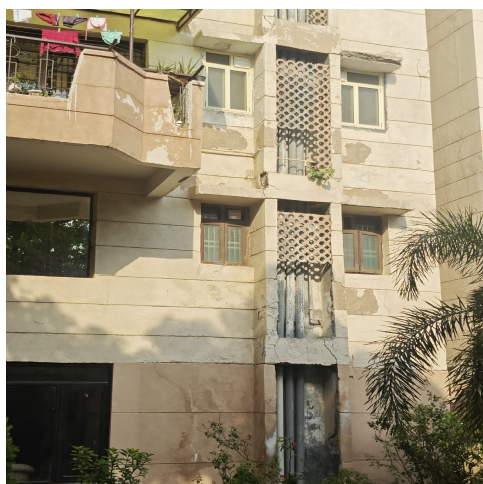
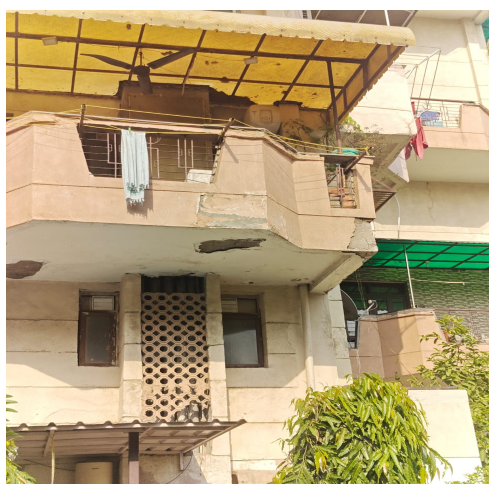
1. Shaft Seepage and Beam Cracks – Type B2 (All Floors)

- Damp patches and cracking were noted in the beams adjacent to the shaft walls across all floors. Leakage from plumbing lines was visible in some shafts.

- Failed waterproofing, plumbing leaks, and long-term exposure to damp conditions.

- Rusting of embedded reinforcement, reduction in concrete strength, interior damage.

- PU injection grouting.
- Plumbing replacement and shaft re-waterproofing.
- Coating inner shaft walls with crystalline sealants.
- Retrofit beams with additional polymer mortar repair.
- Refer Pages 87 to 92 & 114 to 120 of this report.

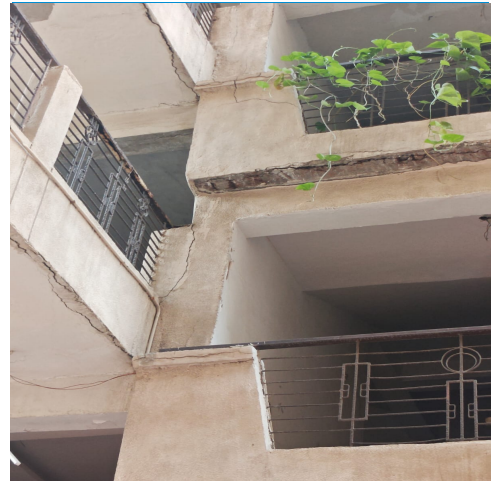
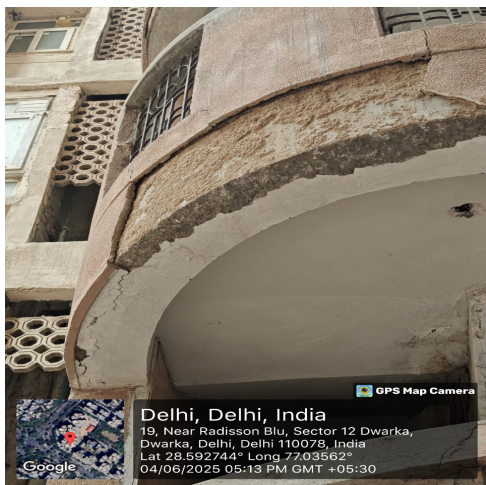
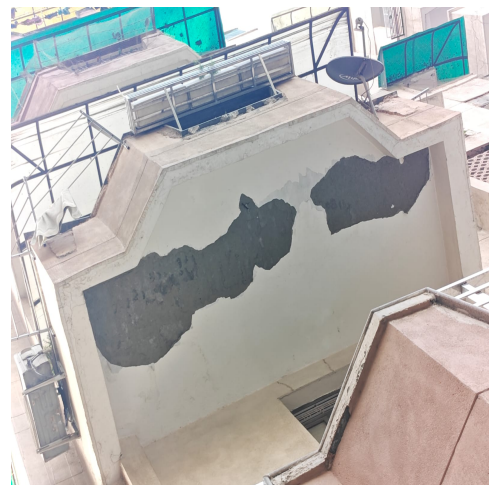
2. Balcony Beam Crack – Type B2

- Crack visible along soffit and cantilever end of the balcony beam on upper floors, with minor concrete delamination.
- Probable Cause of Deterioration:
- Environmental exposure, overloading of cantilever, and concrete fatigue.

- Sagging, spalling, and risk of concrete fragment fall.

- Seal cracks with epoxy.
- Provide adequate water drainage on balcony slab.
- Retrofit beams with additional polymer mortar repair or with additional rebar .
- Refer Pages 87 to 92 & 114 to 120 of this report.

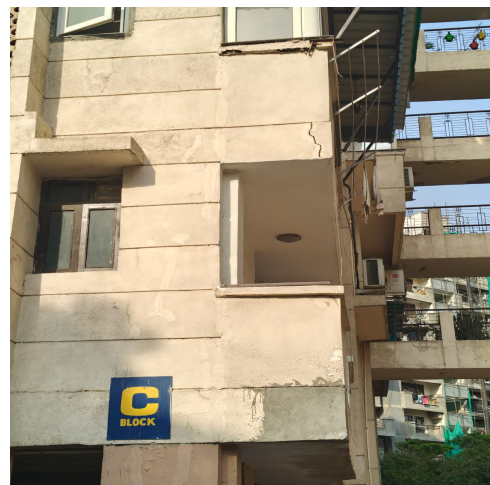
4. Balcony Beam Cracks – Type D (2nd and 4th Floors)

- Diagonal and horizontal cracks were observed in the balcony beams at the 2nd and 4th floors, indicating distress from flexure and rotation.

- Localized failure, detachment risk, and water seepage into rooms.

- Polymer-modified mortar repair.
- steel rebar reinforcement by welding in case existing bar is rusted.
- Retrofit beams with polymer mortar repair.
- Refer Pages 87 to 92 & 114 to 120 of this report.

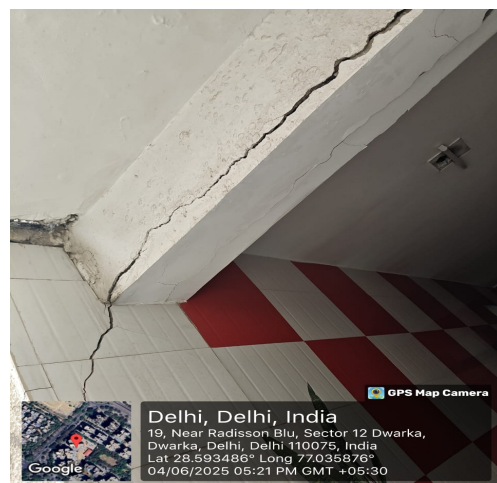
5. Cracks in Passage Columns – Type-D (Ground, 1st, 5th, 6th, 7th Floors)

- Vertical cracks and micro-spalling were found in columns supporting the passage corridor slabs.

- Load cycles from pedestrian traffic, reinforcement corrosion, and settlement.

- Column jacketing with RCC/Retrofit column with additional polymer mortar repair.
- Application of corrosion inhibitors.
- Refer Pages 87 to 92 & 114 to 120 of this report.

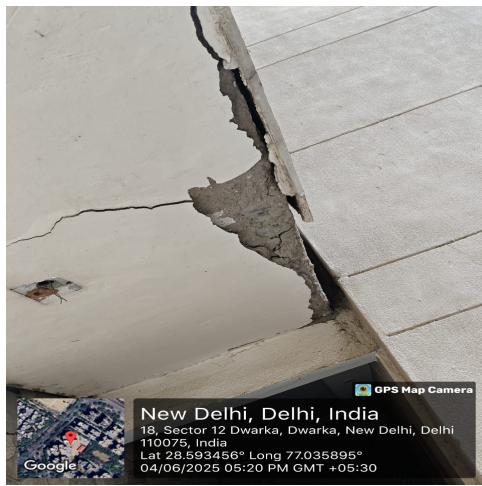
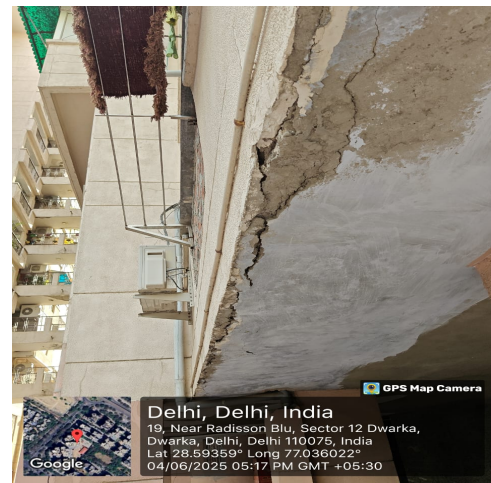
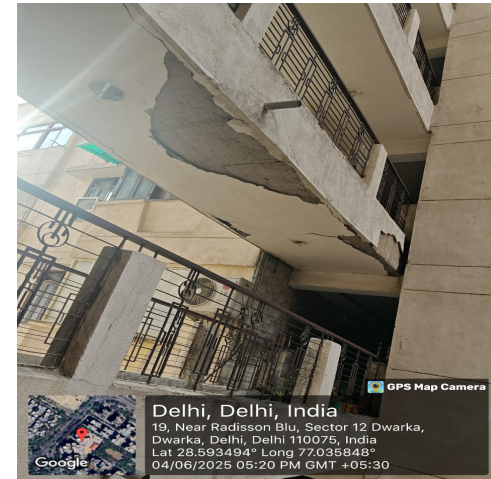
6. Passage Beam Cracks – All Floors

- Hairline to moderate cracks were seen in passage beams throughout all floors, particularly near mid-span and wall supports.
- Probable Cause of Deterioration:
- Overuse, thermal cycling, and lack of expansion joints.

- Risk of structural fatigue, slab settlement, and widening of cracks.

- Repair cracks with epoxy grouting.
- Add steel reinforcements by welding method .
- Refer Pages 87 to 92 & 114 to 120 of this report.
- Retrofit beams with additional bars or polymer mortar repair.
