STRUCTURAL INTEGRITY & ASSESSMENT AUDIT REPORT

KUNJ VIHAR CGHS LTD.

PLOT NO 19, SECTOR 12, DWARKA, NEW DELHI - 110078.

UNIQUE DESIGNERS & ENGINEERS PVT. LTD.

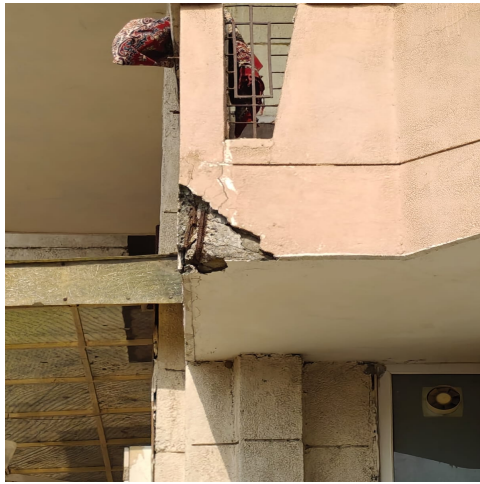
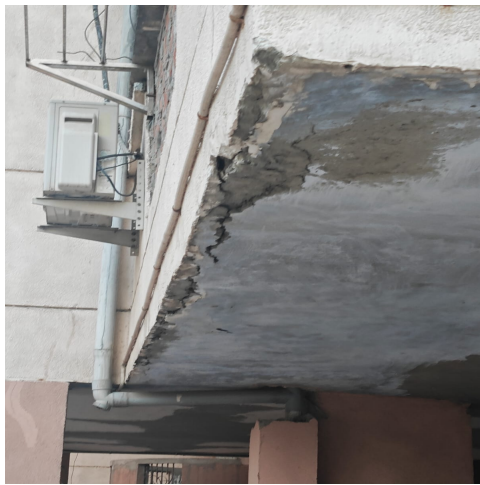
1. Cracks in Balcony Beams – 1st and 3rd Floor

- Linear cracks were observed in the balcony beams on the 1st and 3rd floors. Cracks appear near the cantilever ends, mostly on the soffit (bottom surface), suggesting flexural stress-induced failure.

- These cracks have developed due to prolonged cantilever loading, thermal expansion/contraction, and exposure to weathering.

- Continuous widening of cracks can lead to water seepage, corrosion of embedded reinforcement, spalling of concrete, and eventual reduction in load-bearing capacity of the cantilever elements.

- Inject epoxy grout into cracks.
- For significant distress, use carbon fiber reinforced polymer (CFRP) wrapping.
- Apply waterproofing and slope correction to drain water away from beam surfaces.
- This location contains all three types of cracks—minor, moderate, and major. Kindly refer to the repair methodology and recommended treatments as detailed on Pages 87 to 92 & 114 to 120 of this report. Apply appropriate solutions based on the crack severity observed at each location.

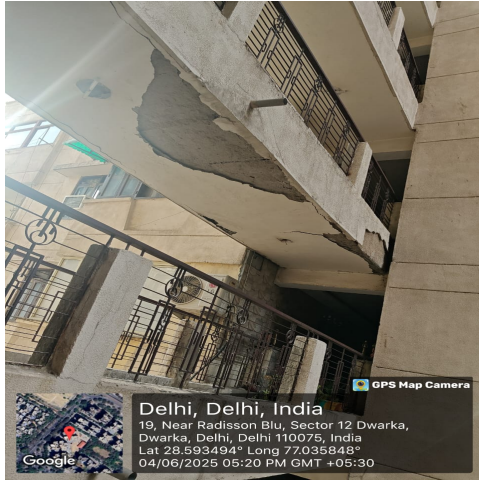
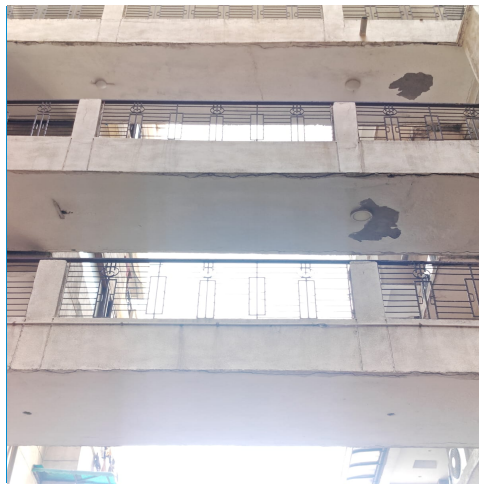
3. Beam Cracks – Ground Floor Passage Between Type A1 and Type A2

- Diagonal and flexural cracks were observed in RCC beams in the passage connecting sections type A1 and type A2. Cracks were most visible near beam-column junctions and mid-spans.

- Cracks are due to accumulated structural loading over time and differential deflection between wings.

- Potential weakening of load paths in a key circulation area. Prolonged inaction can result in deflection, instability, or even progressive cracking along connected members.

- Strengthen using steel jacketing Or RC jacketing or polymer mortar repair/micro concrete.
- Refer repair methodology and recommended treatments as detailed on Pages 987 to 92 & 114 to 120.

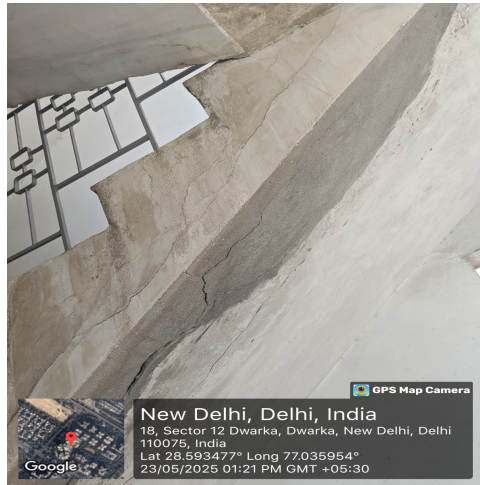
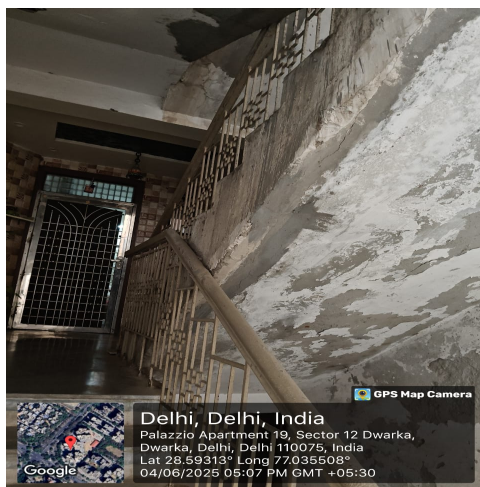
4. Beam Cracks Around Stair Wall – All Floors

- Horizontal and vertical cracks were noticed in beams supporting stair walls on each floor. These cracks were mostly continuous at the same level on every floor, showing consistent stress impact.

- Cracks likely developed due to vibration from regular use, long-term shrinkage, and rigid wall-beam connections lacking movement tolerance.

- Cracks may propagate into adjacent walls and lead to loss of load-sharing capacity between stairs and core beams, posing evacuation and safety concerns.

- Apply sealants in cracks.
- Retrofit stair beams with additional rebar or polymer mortar repair or micro concrete.
- Pages refer 87 to 92 & 114 to 120.

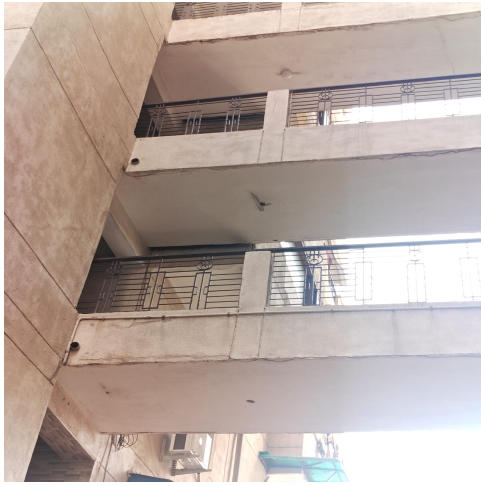
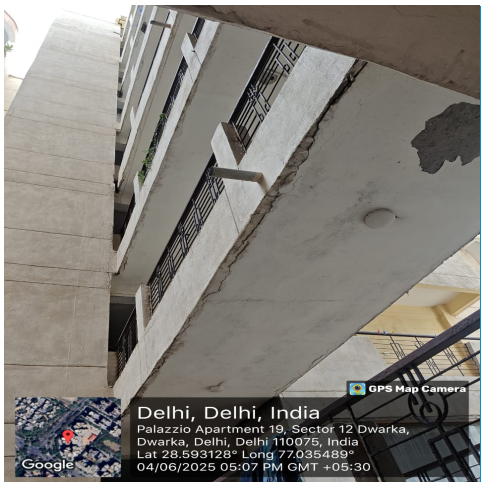
5. Beam Crack at Passage End – 1st Floor

- A significant crack was identified at the end of the passage beam at the 1st floor junction, where differential structural movement appears to have concentrated stress.

- This is a service-related crack due to edge restraint, unequal support stiffness, or improper load transfer over time.

- Stress concentration may induce torsional cracking or lead to eventual shear failure if left unattended.

- Add additional reinforcement if exposed (by weld method).
- Retrofit stair beams with additional rebar or polymer mortar repair or use micro concrete.
- Monitor with strain gauges for movement tracking.
- Refer to the repair methodology and recommended treatments as detailed on Pages 87 to 92 & 114 to 120 of this report.

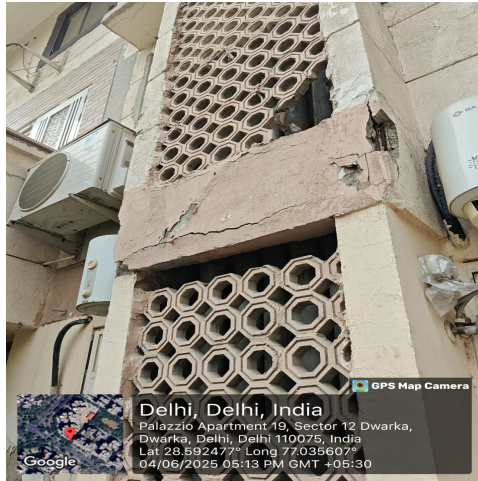
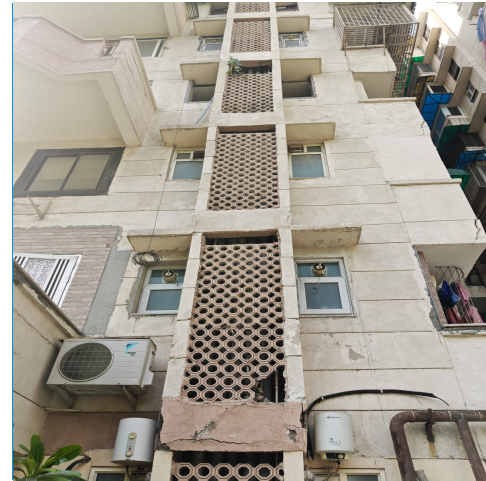
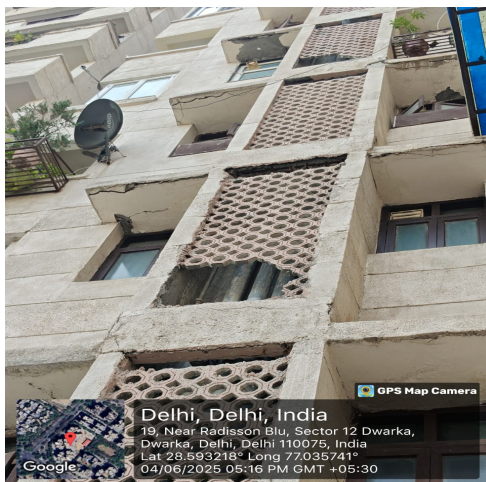
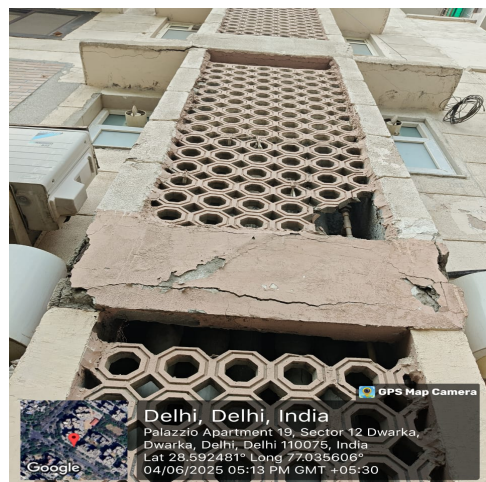
6. Shaft Wall Cracks – TYPE-B1,(All Floors)

- Vertical cracking with spalling of cover concrete was found in shaft walls across floors. In some areas, visible reinforcement corrosion was also noted.

- The cause is expansion and contraction of conduits, unprotected openings, and long-term water ingress.

- Weakening of shaft enclosure, collapse of non-structural walls, exposure of reinforcement to accelerated corrosion.

- Apply waterproof mortar coating.
- Isolate plumbing to reduce dynamic stress.
- Refer Pages 87 to 92 & 114 to 120 of this report.

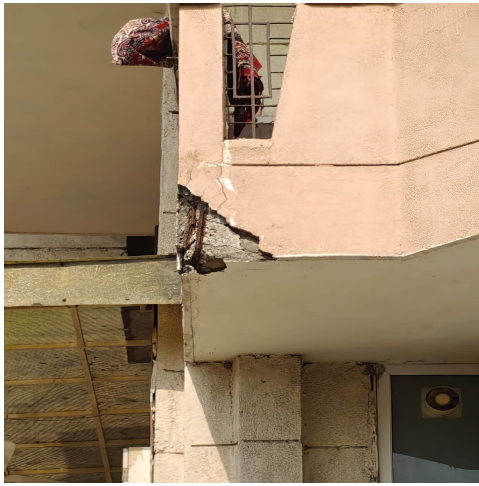
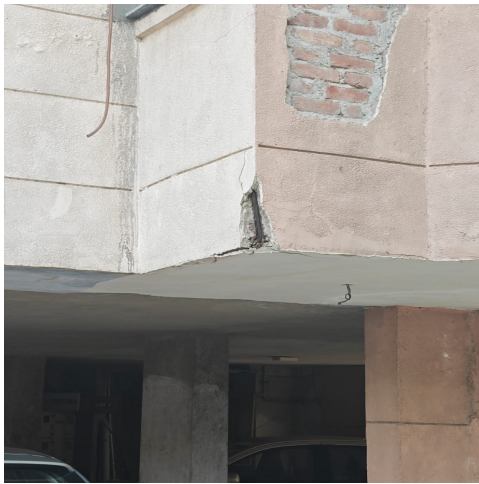
7. Balcony Crack – TYPE-C2 (1st Floor)

- A wide flexural crack was seen at the base of the balcony slab near the wall connection.

- Crack likely due to cantilever stress, temperature fluctuation, and insufficient drainage leading to water retention.

- This location contains all three types of cracks—minor, moderate, and major. Kindly refer to the repair methodology and recommended treatments as detailed on Pages 87 to 92 & 114 to 120 of this report. Apply appropriate solutions based on the crack severity observed at each location.

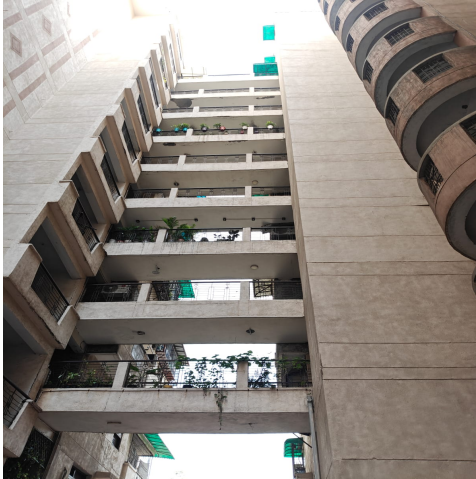
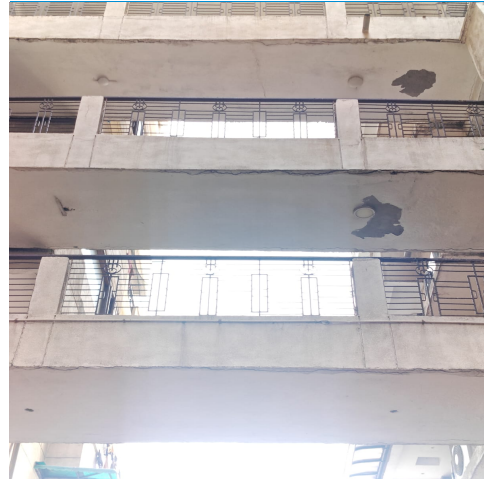
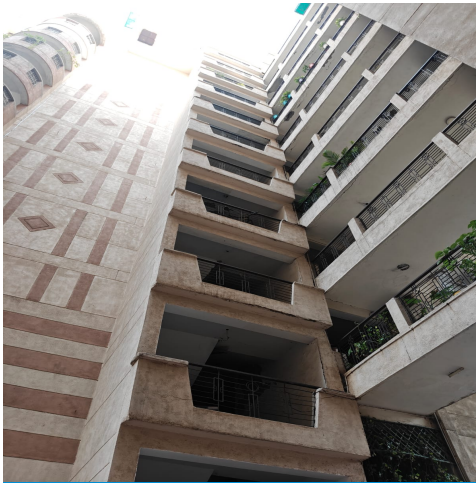
- Seepage marks and damp patches were observed on the floor slabs and sidewalls of the passage areas on multiple levels. Numerous potted plants are placed along the passage, and excessive watering was noted. Rust stains are also visible on some ceiling surfaces, indicating ongoing reinforcement corrosion.

- Continuous and excessive watering of potted plants has resulted in water accumulation and seepage through slab joints and cracks. Lack of waterproofing and proper drainage has allowed moisture to reach embedded reinforcement.

- Corrosion of reinforcement leading to expansion and cracking of concrete.
- Gradual weakening of the slab and reduced load-bearing capacity.
- Fungal/mold growth affecting aesthetics and hygiene.
- Degradation of plaster and paint layers.

- Relocate plants or place waterproof trays below pots.
- Perform anti-corrosive treatment and patch repair where rusting is evident.
- Apply waterproofing treatment to slab surfaces.
- Replaster and repaint with moisture-resistant materials.
- Regular monitoring for corrosion signs in affected zones.

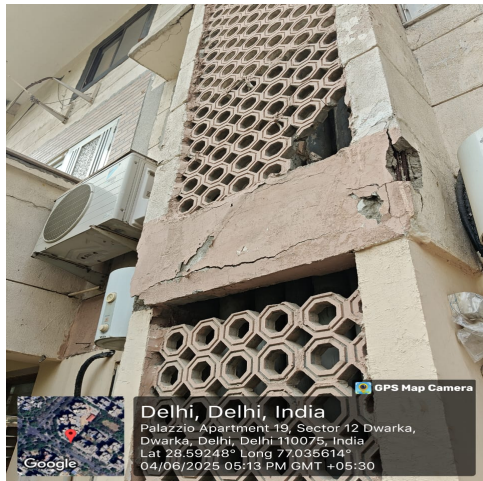
1. Shaft Seepage and Beam Cracks – Type B2 (All Floors)

- Damp patches and cracking were noted in the beams adjacent to the shaft walls across all floors. Leakage from plumbing lines was visible in some shafts.

- Failed waterproofing, plumbing leaks, and long-term exposure to damp conditions.

- Rusting of embedded reinforcement, reduction in concrete strength, interior damage.

- PU injection grouting.
- Plumbing replacement and shaft re-waterproofing.
- Coating inner shaft walls with crystalline sealants.
- Retrofit beams with additional polymer mortar repair.
- Refer Pages 87 to 92 & 114 to 120 of this report.

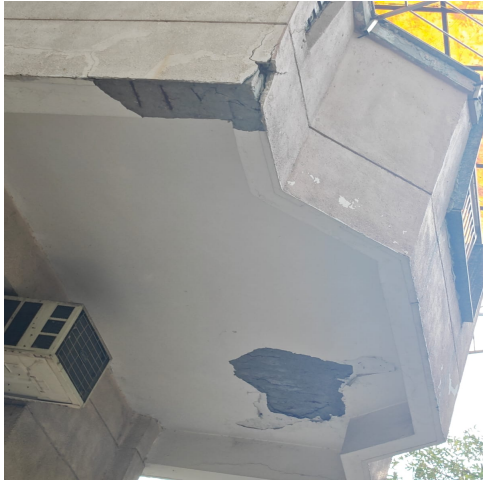
2. Balcony Beam Crack – Type B2

- Crack visible along soffit and cantilever end of the balcony beam on upper floors, with minor concrete delamination.
- Probable Cause of Deterioration:
- Environmental exposure, overloading of cantilever, and concrete fatigue.

- Sagging, spalling, and risk of concrete fragment fall.

- Seal cracks with epoxy.
- Provide adequate water drainage on balcony slab.
- Retrofit beams with additional polymer mortar repair or with additional rebar .
- Refer Pages 87 to 92 & 114 to 120 of this report.

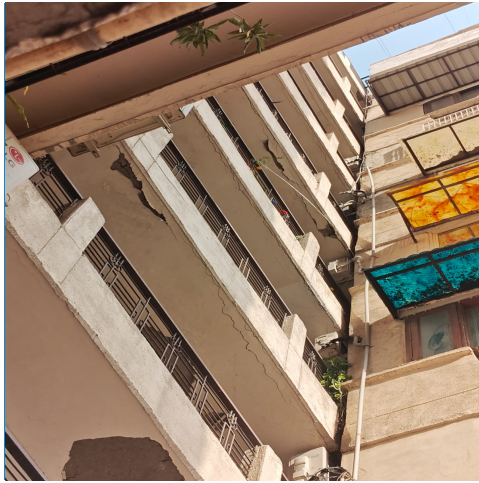
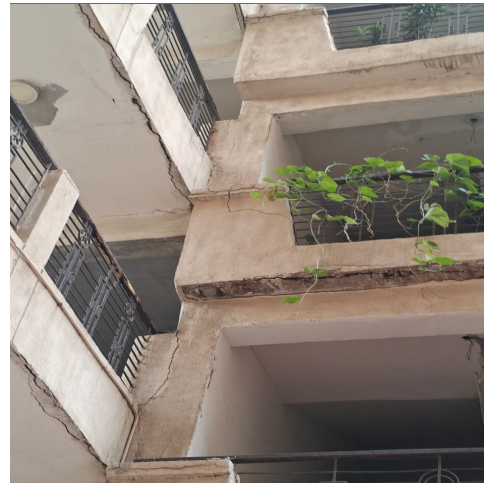
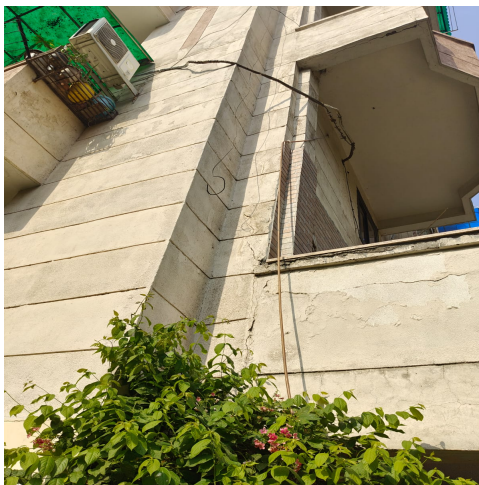
4. Balcony Beam Cracks – Type D (2nd and 4th Floors)

- Diagonal and horizontal cracks were observed in the balcony beams at the 2nd and 4th floors, indicating distress from flexure and rotation.

- Localized failure, detachment risk, and water seepage into rooms.

- Polymer-modified mortar repair.
- steel rebar reinforcement by welding in case existing bar is rusted.
- Retrofit beams with polymer mortar repair.
- Refer Pages 87 to 92 & 114 to 120 of this report.

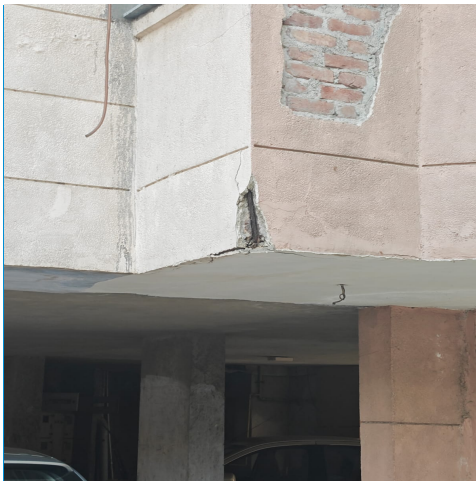
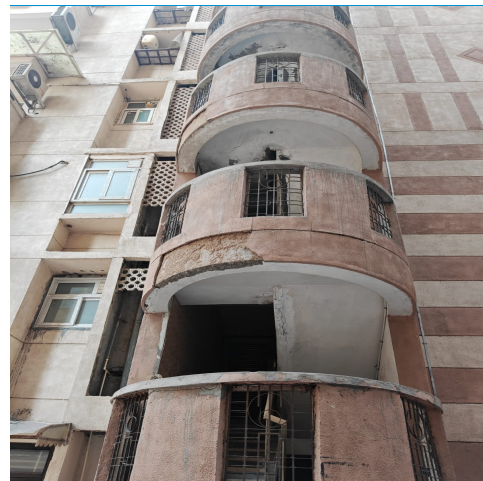
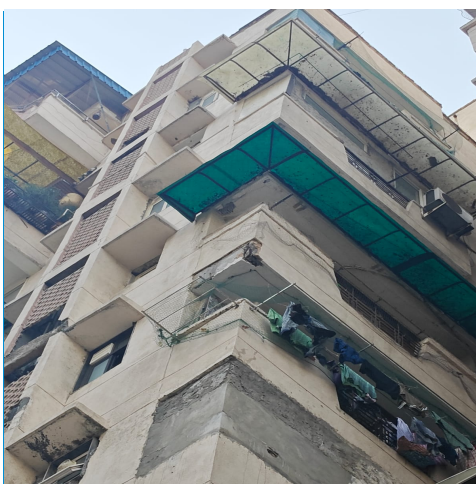
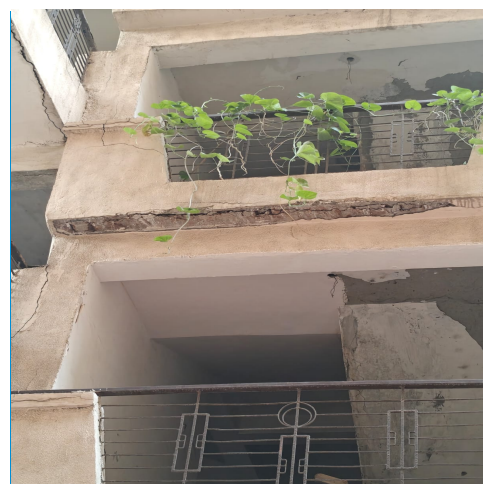
2. Balcony Crack – Type A (3rd Floor)

- The cantilever slab of the balcony at the 3rd floor showed transverse and edge cracks, some over 3 mm in width. Surface spalling was visible near the front edge, and signs of seepage and weathering were evident.

- Flexural fatigue from prolonged cantilever stress, inadequate water drainage leading to pooling, and thermal stress cycles causing concrete degradation.

- Structural weakening of the balcony, leading to reduced safety margins, reinforcement corrosion, and potential falling hazards.

- Repair the cracks using polymer-modified concrete.
- Strengthen the cracks with a additional reinforcement by weld method if required.
- This location contains all three types of cracks—minor, moderate, and major. Kindly refer to the repair methodology and recommended treatments as detailed on Pages 87 to 92 & 114 to 120 of this report. Apply appropriate solutions based on the crack severity observed at each location.

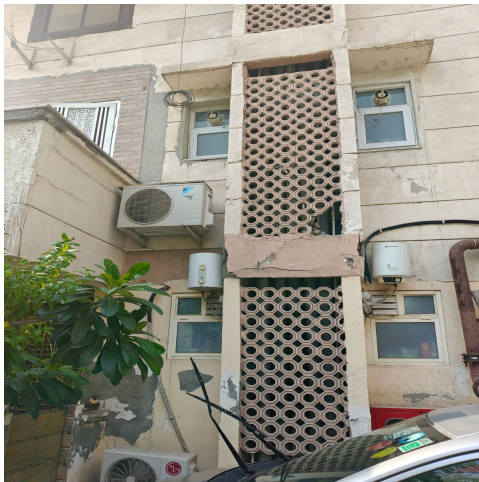
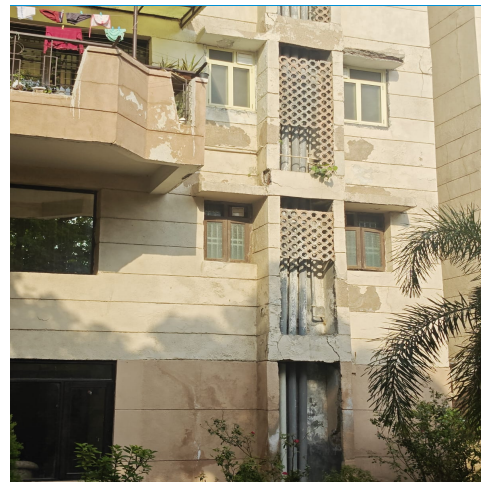
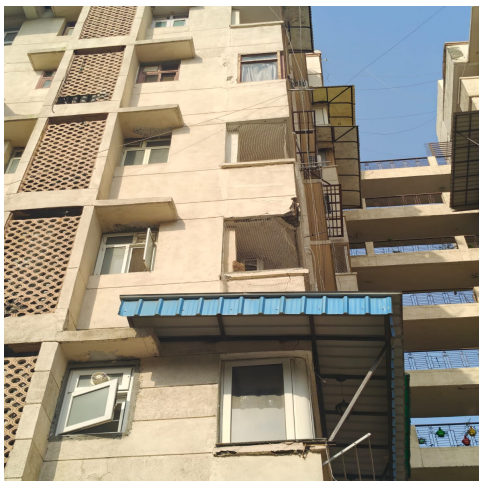
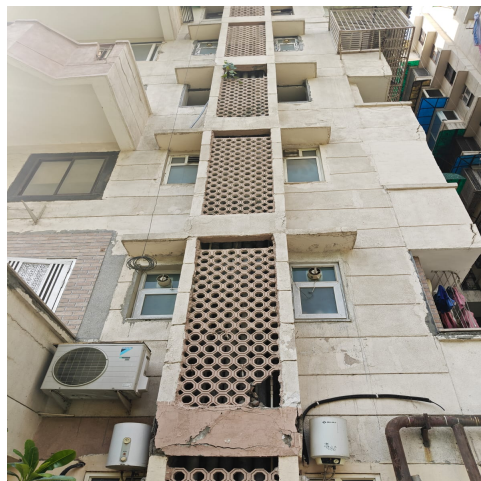
- Vertical shafts exhibited continuous dampness, visible pipe joint leaks, and peeling of internal surface coatings. In several areas, calcified deposits and fungal patches were noted.

- Failure of waterproofing and insulation, cracked or aged service pipes, thermal expansion of conduits stressing wall seals, and lack of shaft ventilation.

- Compromised integrity of shaft walls, corrosion of embedded reinforcement, pipe degradation, and poor hygiene conditions.

- Apply PU-based injection grouting in cracks.
- Replace leaking joints and provide pipe sleeves.
- Use breathable yet water-tight shaft coatings.
- Improve shaft airflow via mechanical or passive ventilation.

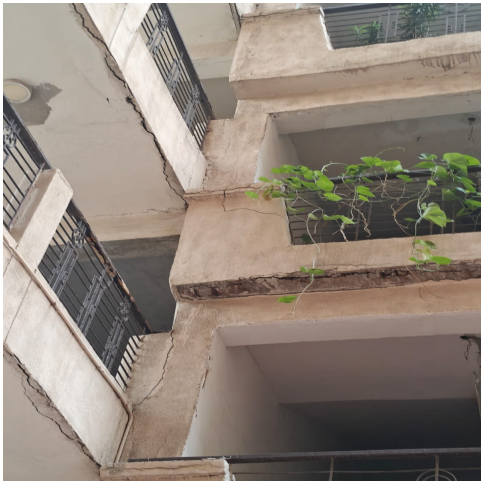
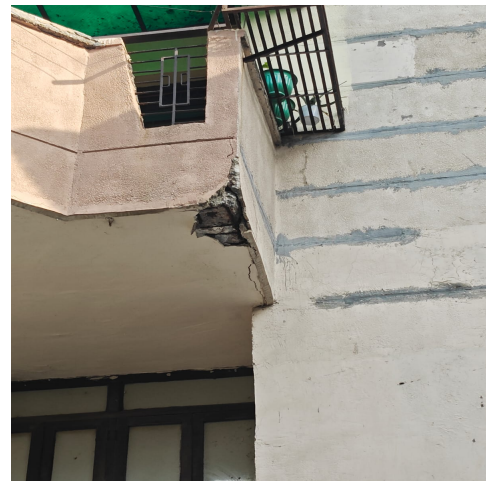
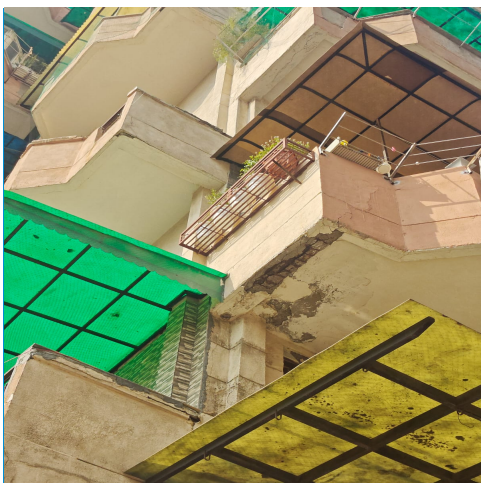
4. Balcony Cracks – Type B1 (2nd and 8th Floors)

- Balcony slabs on these floors showed diagonal cracks and surface deterioration. Crack width was between 1–4 mm and appeared deeper near the outer corners.

- Lack of slope, continuous exposure to weather, and improper detailing at cantilever edges allowing water ingress and reinforcing bar corrosion.

- Risk of edge failure, reinforcement corrosion leading to further cracking, and potential water seepage into interiors below.

- Repair cracks using high-adhesion epoxy mortar.
- Strengthen the cracks with a additional reinforcement by weld method .
- Monitor for slab deflection using optical or laser methods.
- Page refer 87 to 92 &114 to 120.

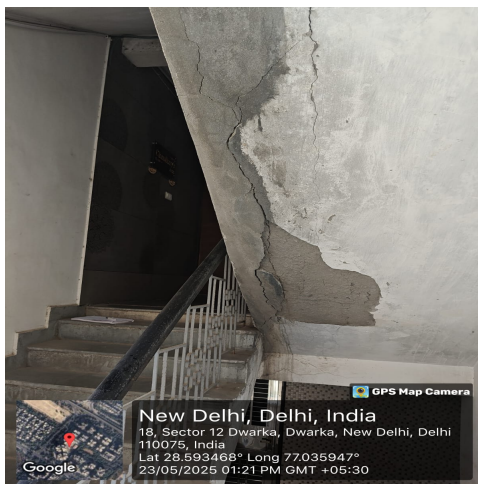
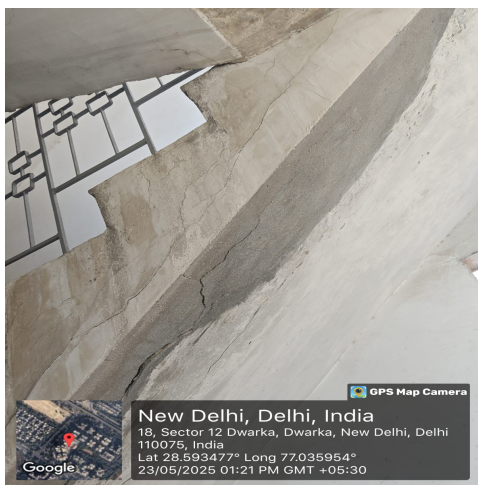
5. Stair Beam Cracks – Type C1

- Cracks in stair-supporting beams were found on multiple landings. Cracks ran transversely and diagonally from beam ends toward the mid-span.

- Reduction in support strength, risk of disconnection between stairs and structural core, and unsafe conditions for emergency evacuation.

- Repair with crack injection and polymer-concrete overlays.
- Strengthen the beam with an additional reinforcement by weld method if bar is badly rusted.
- Retrofit stair beams with polymer mortar/micro concrete repair.
- Page refer to 87 to 92 & 114 to 120.

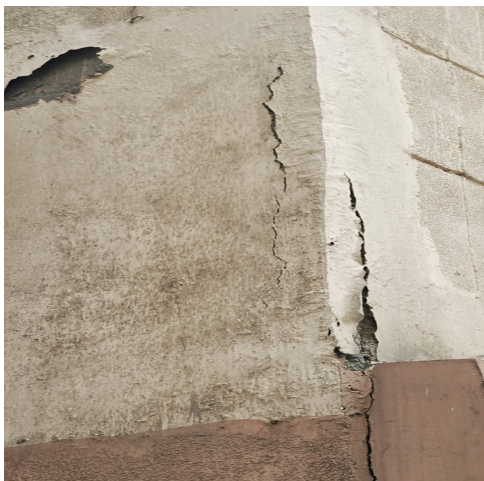
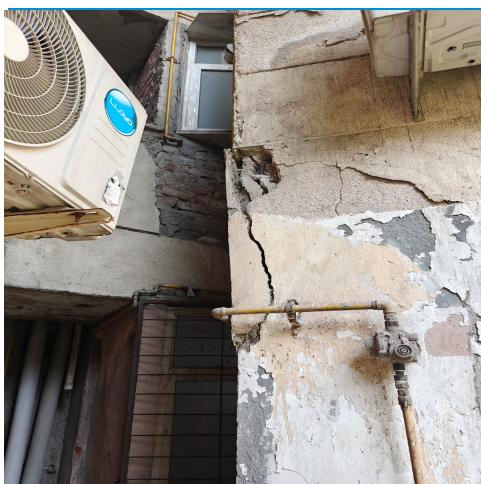
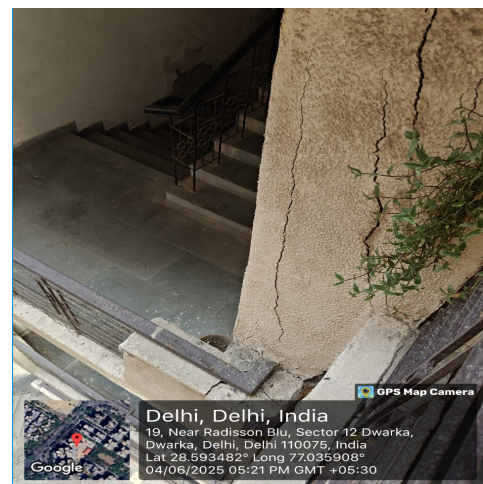
6. Column Cracks – Type C2 (All Floors)

- Vertical cracks up to 5 mm wide were observed along the faces of columns from ground to top floors. Rust streaks and cover spalling were visible in some areas.

- Weathering of external columns, loss of protective cover, carbonation, and internal corrosion of longitudinal rebars.

- Degradation of load-bearing capacity, risk of structural instability during lateral events (wind, seismic), and eventual rebar failure.

- Retrofit with polymer mortar repair/Micro concrete.
- Jacketing using steel bars for damaged columns.
- page refer to 87 to 92 & 114 to 120.

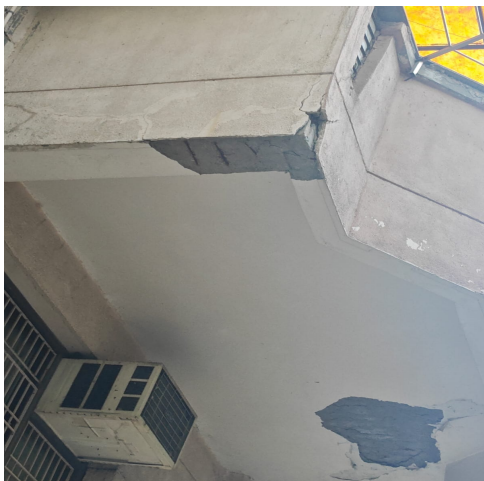
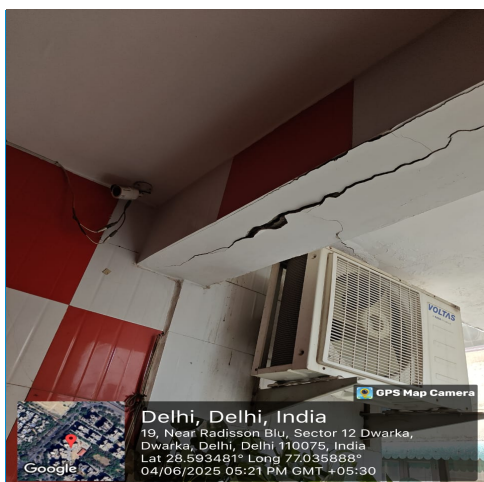
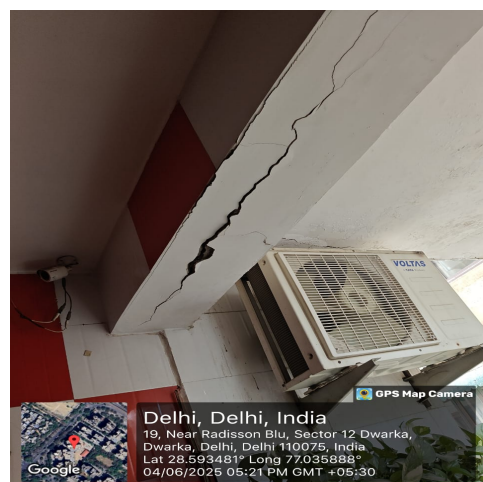
8. Beam Cracks – Type B1 (1st and 3rd Floors)

- Beams displayed multiple longitudinal cracks and minor deflection at the mid-span. Steel exposure was noted at crack sites, with water stains nearby.
- Probable Cause of Deterioration:
- Aging of concrete, bar corrosion causing cracking through expansion, and long-term service loading.

- Flexural failure under high loads, widening of cracks, water infiltration into lower floors.

- Retrofit beams with additional bars & polymer mortar repair/micro concrete.
- Replace exposed and rusted rebars and weld new bars.
- Page refer to 87 to 92 & 114 to 120.

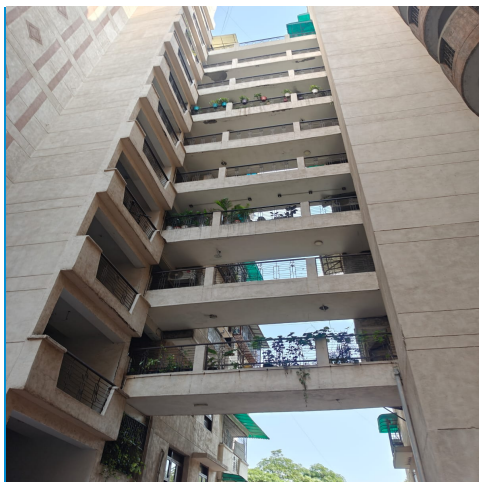
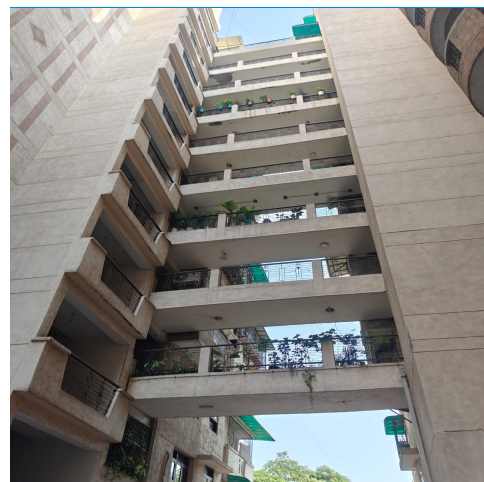
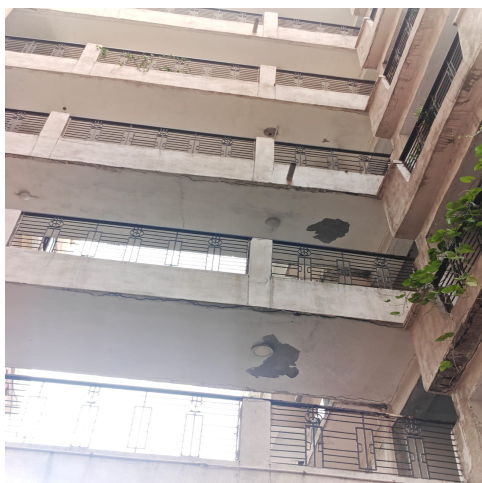
- Seepage stains, damp ceiling patches, and salt deposits (efflorescence) noted in several locations under potted plant zones. Rust streaks and localized concrete delamination were also observed, indicating corrosion of internal reinforcement.

- Continuous watering of plants without drainage control has allowed water to percolate into the slab, initiating corrosion in rebars and degrading surface finishes.

- Rusting of reinforcement, causing cracking and section loss.
- Increased maintenance costs and potential structural safety concerns.
- Formation of damp, unsightly surfaces with health and slip hazards.

- Remove plants from critical slab zones or use controlled irrigation methods.
- Conduct detailed assessment for corrosion extent using NDT methods.
- Repair affected concrete and provide rust inhibition treatment.
- Apply waterproof coatings and ensure future moisture isolation.

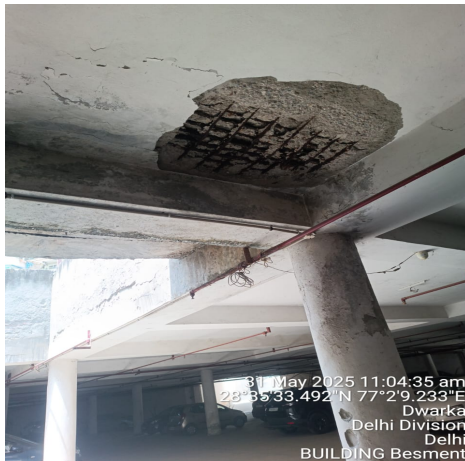
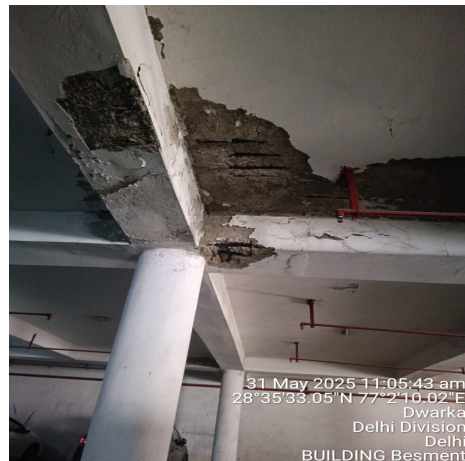
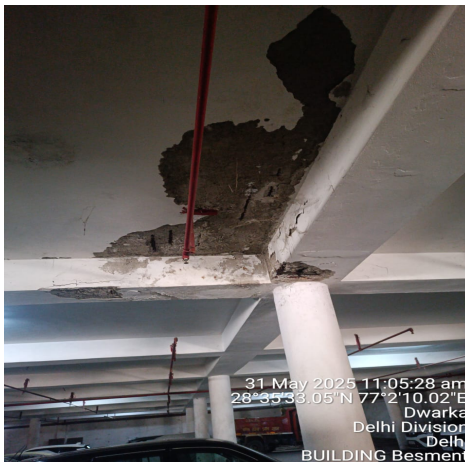
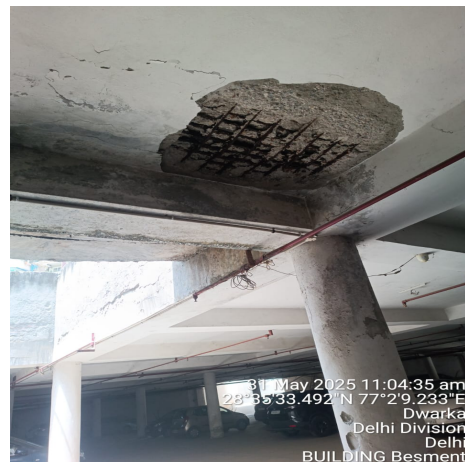
- Clear cover has deteriorated at several locations in the slab, leading to exposed and rusted reinforcement bars. Spalling and delamination are visible around affected zones.

- Prolonged exposure to moisture, carbonation of concrete, and inadequate maintenance led to corrosion of rebars. Aging and environmental effects have reduced the effectiveness of the cover.

- For minor cracks, apply polymer-based cement mortar directly after cleaning and surface preparation.
- Fill the prepared mortar around the reinforcement, compact properly, and level the surface before final setting.

- Maintain curing for 7 days using water spray or curing compound.
- Refer to Pages 87 to 92 & 114 to 120 of this report for detailed methodology and illustrations.

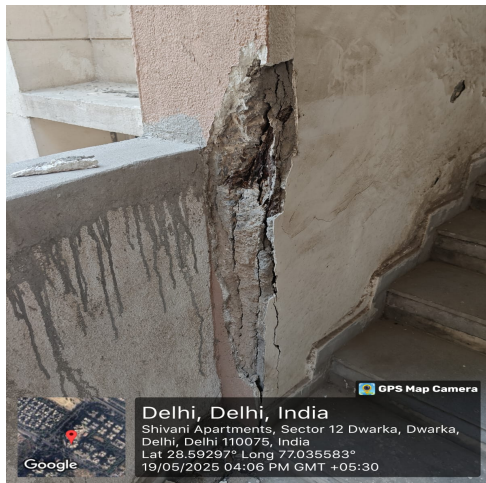
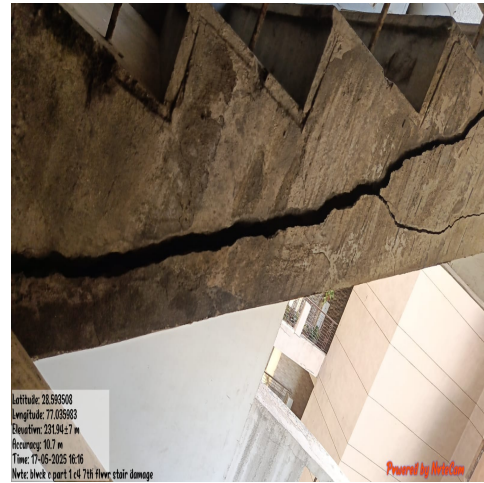
3. Major Cracks

- Crack Width: > 1.4 mm

Nature: Structural cracks indicating distress in load-bearing components

- Conduct a detailed structural evaluation to determine the extent of damage and whether the structural integrity is compromised.
- Perform load analysis and check for rebar corrosion, deflection, or loss of section.

- Carefully chisel and widen the cracks to expose the full depth.
- Clean the area using water and compressed air to remove all dust, loose concrete, and corroded material.

- For severely distressed beams or columns, provide RC or steel jacketing:
 - RC Jacketing: Roughen the existing surface, In case the existing reinforcement is rusted or corroded, weld additional bars to restore the required reinforcement continuity.

- Where member strength is significantly reduced, implement retrofitting using appropriate techniques and materials:
 - Section enlargement to increase load-carrying capacity of beams and columns using M25 micro-concrete.
 - Stitching of cracks using steel bars for added confinement and integrity.
 - For wall retrofitting, use polymer-based cement mortar in combination with chicken mesh to improve bonding and surface restoration.

- Expose rebars, clean corrosion with wire brush/grinder.
- Apply zinc-rich primer or corrosion inhibitor.
- Replace bars if cross-sectional loss exceeds 25%.

- Apply high-strength polymer-modified repair mortar in layers.
- Ensure proper compaction and bonding to parent concrete.

- Cure using wet hessian cloth or curing compound for a minimum of 10–14 days.

- **Protective Surface Coating:** Finish with a breathable anti-carbonation coating or elastomeric waterproof paint.
- **Load Redistribution:** Modify loading arrangements temporarily if structural safety is affected.
- **Drawings:** Attach detailed strengthening and jacketing drawings to support the repair process.
- **Monitoring:** Conduct post-repair monitoring using crack gauges or sensors.
